REPORT OF AIRCRAFT ACCIDENT

44-7-6-59
4009

(1) Place Harding Field, Baton Rouge, Louisiana (2) Date 6 July 1943 (3) Time 0857
AIRCRAFT: (4) Type and model A-20G-10 (5) A. F. No. 42-54025 (6) Station Lake Charles AAB, La.
Organization: (7) III ASC III AF (8) 416 Bomb (L) (9) 670th Bomb (L)
(Command and Air Force) (Group) (Squadron)

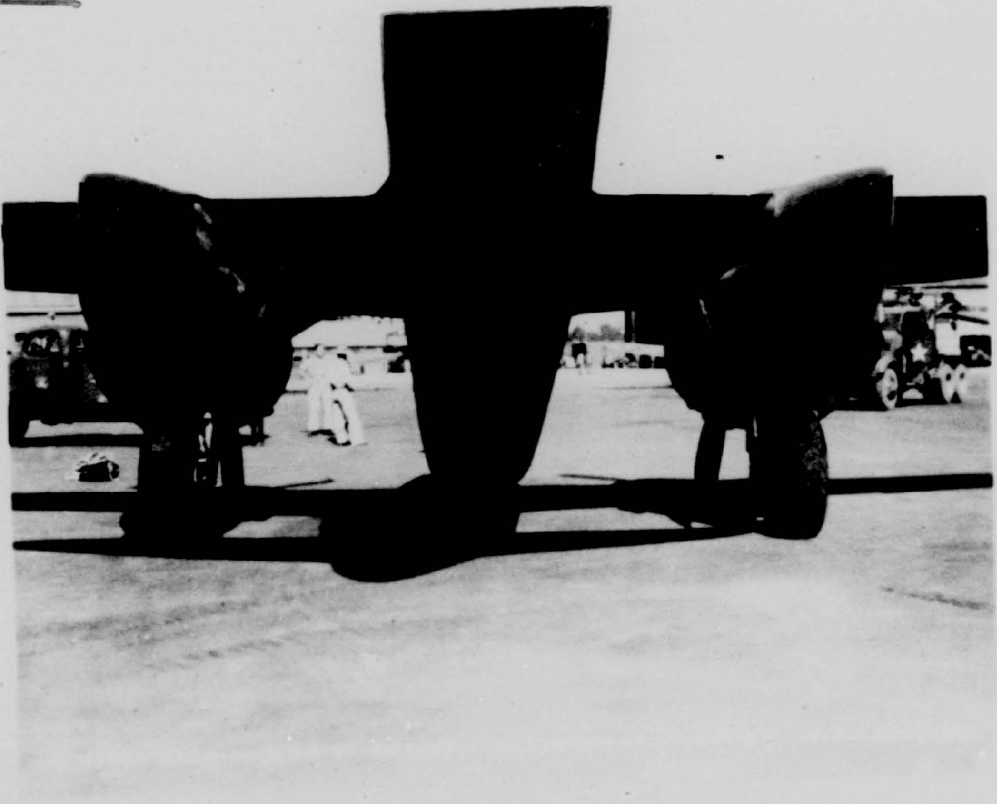
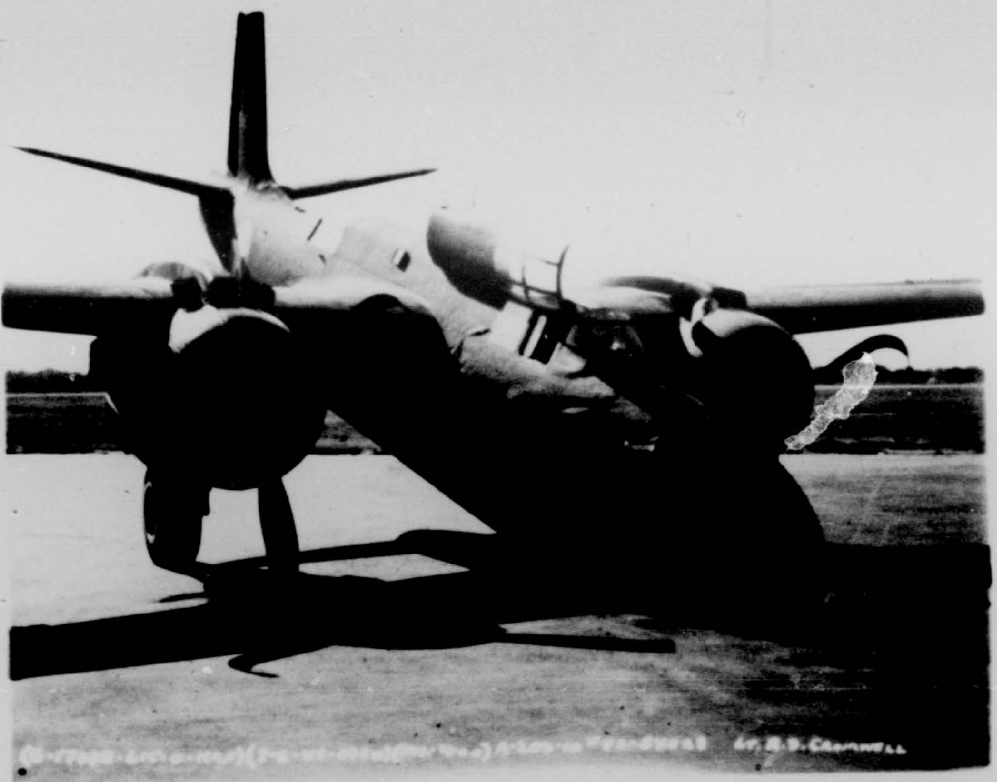
After landing, pilot taxied plane well past the intersection and lost all his airspeed when his nose wheel buckled backwards about 35 - 45° and then straightened out. Pilot was warned by the control tower as he turned off the runway on to the ramp. He reached the parking area safely. As the ship came to a rest, the nose wheel buckled completely.

Louisiana WHEN PILOT put on brakes nose wheel retracted.
RECEIVED THE FOLLOWING DAMAGES:

Propellers (depot reparable)
Fuselage (not reparable)
Nose wheel doors (not reparable)

Recommendation - More thorough inspection be made of nose wheel assembly at each 25 hour inspection. When trouble is suspected, plane should be stopped regardless of position on runway and have crew chief make a thorough check to ascertain whether further taxiing can be safely accomplished.
