WAR DEPARTMENT
U. S. ARMY AIR FORCES
REPORT OF AIRCRAFT ACCIDENT

48-019
(1) Place Army Air Field, Lake Charles, La. (2) Date 25 Sept 43 (3) Time 0835 GMT
AIRCRAFT: (4) Type and model A-20C-15 (5) A. P. No. 42-51347 (6) Station AAF, Lake Charles, La.
Organization: (7) 3rd Bomb. Comd. (8) 116th Bomb. (Group) (9) 668th Bomb. (Squadron)
3 3B PERSONNEL BLL BLL 8860

DESCRIPTION OF ACCIDENT

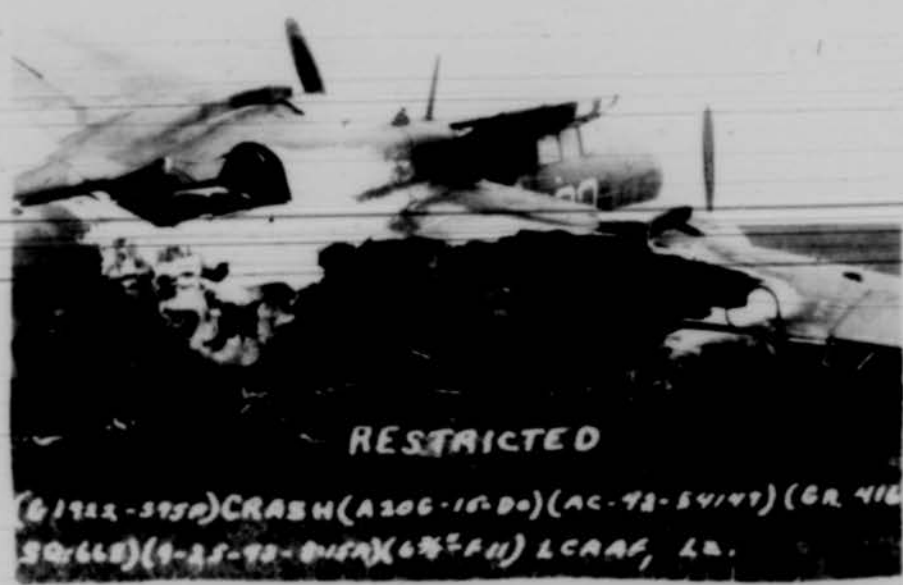
(6192-3950) CRASH (A306-15-00) (AC-78-54147) (GR 416
80-668) (9-25-78-0157) (67-7-11) LCAAF, LA.

DAMAGE	(46) LIST OF DAMAGED PARTS
(46) Aircraft..... <u>W 5</u>	<u>Right wing, fuselage, right nacelle and landing gear burned beyond repair.</u>
(47) Engine(s)..... <u>None 1</u>	
(48) Propeller(s)..... <u>None 1</u>

The main gasoline lines were burned in two, which made the fire difficult to extinguish.

Following the fire, it was impossible to get any idea as to how the fire originated, due to the burned condition of the nacelles, landing gear, wing, etc., but the past experience of Mr. Norman H. Milstead, Douglas Aircraft representative, sheds light on a very possible cause of the fire, as he has seen similar occurrences, and in a couple of cases, the fire was extinguished before too much damage was done, and the following explanation for these fires, which could apply to this fire is offered: The fuel pressure gauge line, carburetor to hose fitting on the fire wall, became disconnected, allowing gasoline to run down the front of the fire wall and into the nacelles through the nacelle doors, and the gasoline was ignited by the exhaust. Following this, the main gasoline lines from the two right tanks were burned through, causing the greatest part of the fire.

1. It is the opinion of the committee that the cause of the accident was material failure.

1. That fuel pressure gauge lines on all B-7 and A-20 type airplanes be replaced with flexible lines as installed in A-20C-20D0 type airplanes.
2. That above connections be observed closely on each preflight inspection for an indefinite period of time.
3. That fire extinguisher equipment for both the engine and accessory section be kept in training type airplanes.
