WAR DEPARTMENT
HEADQUARTERS ARMY AIR BASE, DREW FIELD
U. S. ARMY AIR FORCES

REPORT OF AIRCRAFT ACCIDENT

44-10-27-31

(1) Place Drew Field, Tampa, Florida (2) Date 27 Oct 43 (3) Time 0925 EWT
 AIRCRAFT: (4) Type and model AC-24A (5) A. E. No. 42-6760 (6) Station Lake Charles AAB, La.
 Organization: (7) 3rd BC - 3rd AF (8) 416th Bomb (L) (9) 668th Bomb (L)
(Command and Air Force) (Group) (Squadron)

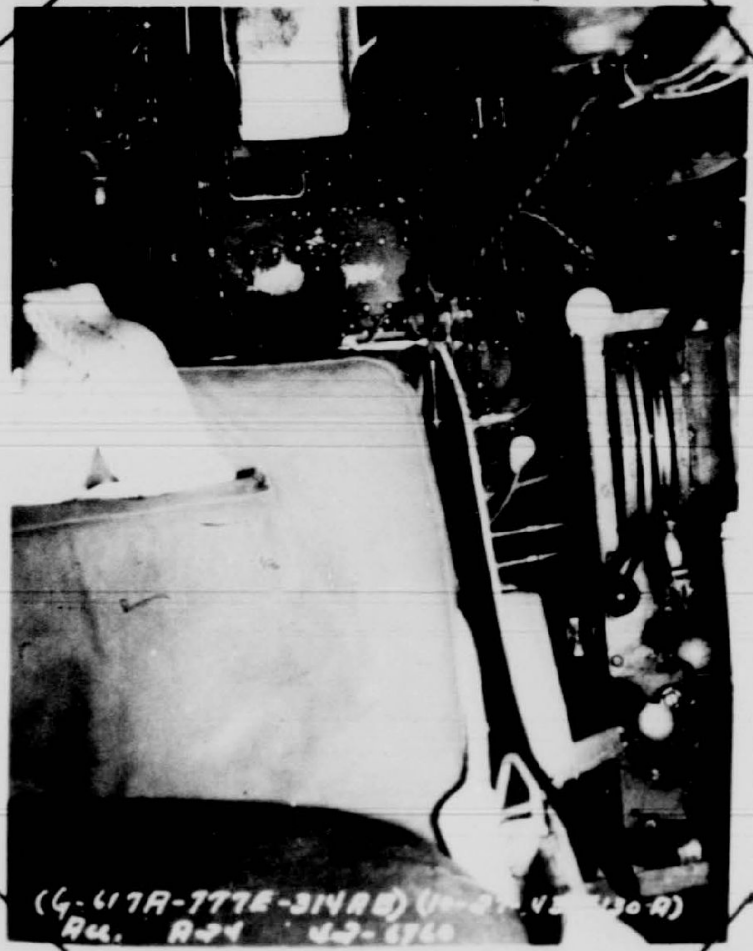
(G-417A-777E-314AB) (10-27-43-1130A)
 Acc. A-24 42-6760

c. It is the opinion of the Aircraft Accident Officer that the pilot is responsible for this accident. The picture of the cockpit (Incl. #8) shows the landing gear control handle to be in the "up" position.
