WAR DEPARTMENT
U. S. ARMY AIR FORCES
REPORT OF AIRCRAFT ACCIDENT

(1) Place Keesler Field, Mississippi (2) Date 26 November 1943 (3) Time 1900 CWT 7
AIRCRAFT: (4) Type and model A-20G-20 (5) A. F. No. 286624 (6) Station BS - Laurel, Miss.
Organization: (7) 3 Bomb Com-III AF (8) 416 Light Bomb (9) 670 Light Bomb
(Command and Air Force) (Group) (Squadron)

(56) Nature of accident Miscellaneous. Collision after jumping checks and swerving into a plane which was parked adjacent to it.
(57) Cause of accident Apparent inability of crewman to definitely determine whether parking brakes were fully applied and throttle in a near closed setting before starting engines on an unlighted portion of airfield during hours of darkness.

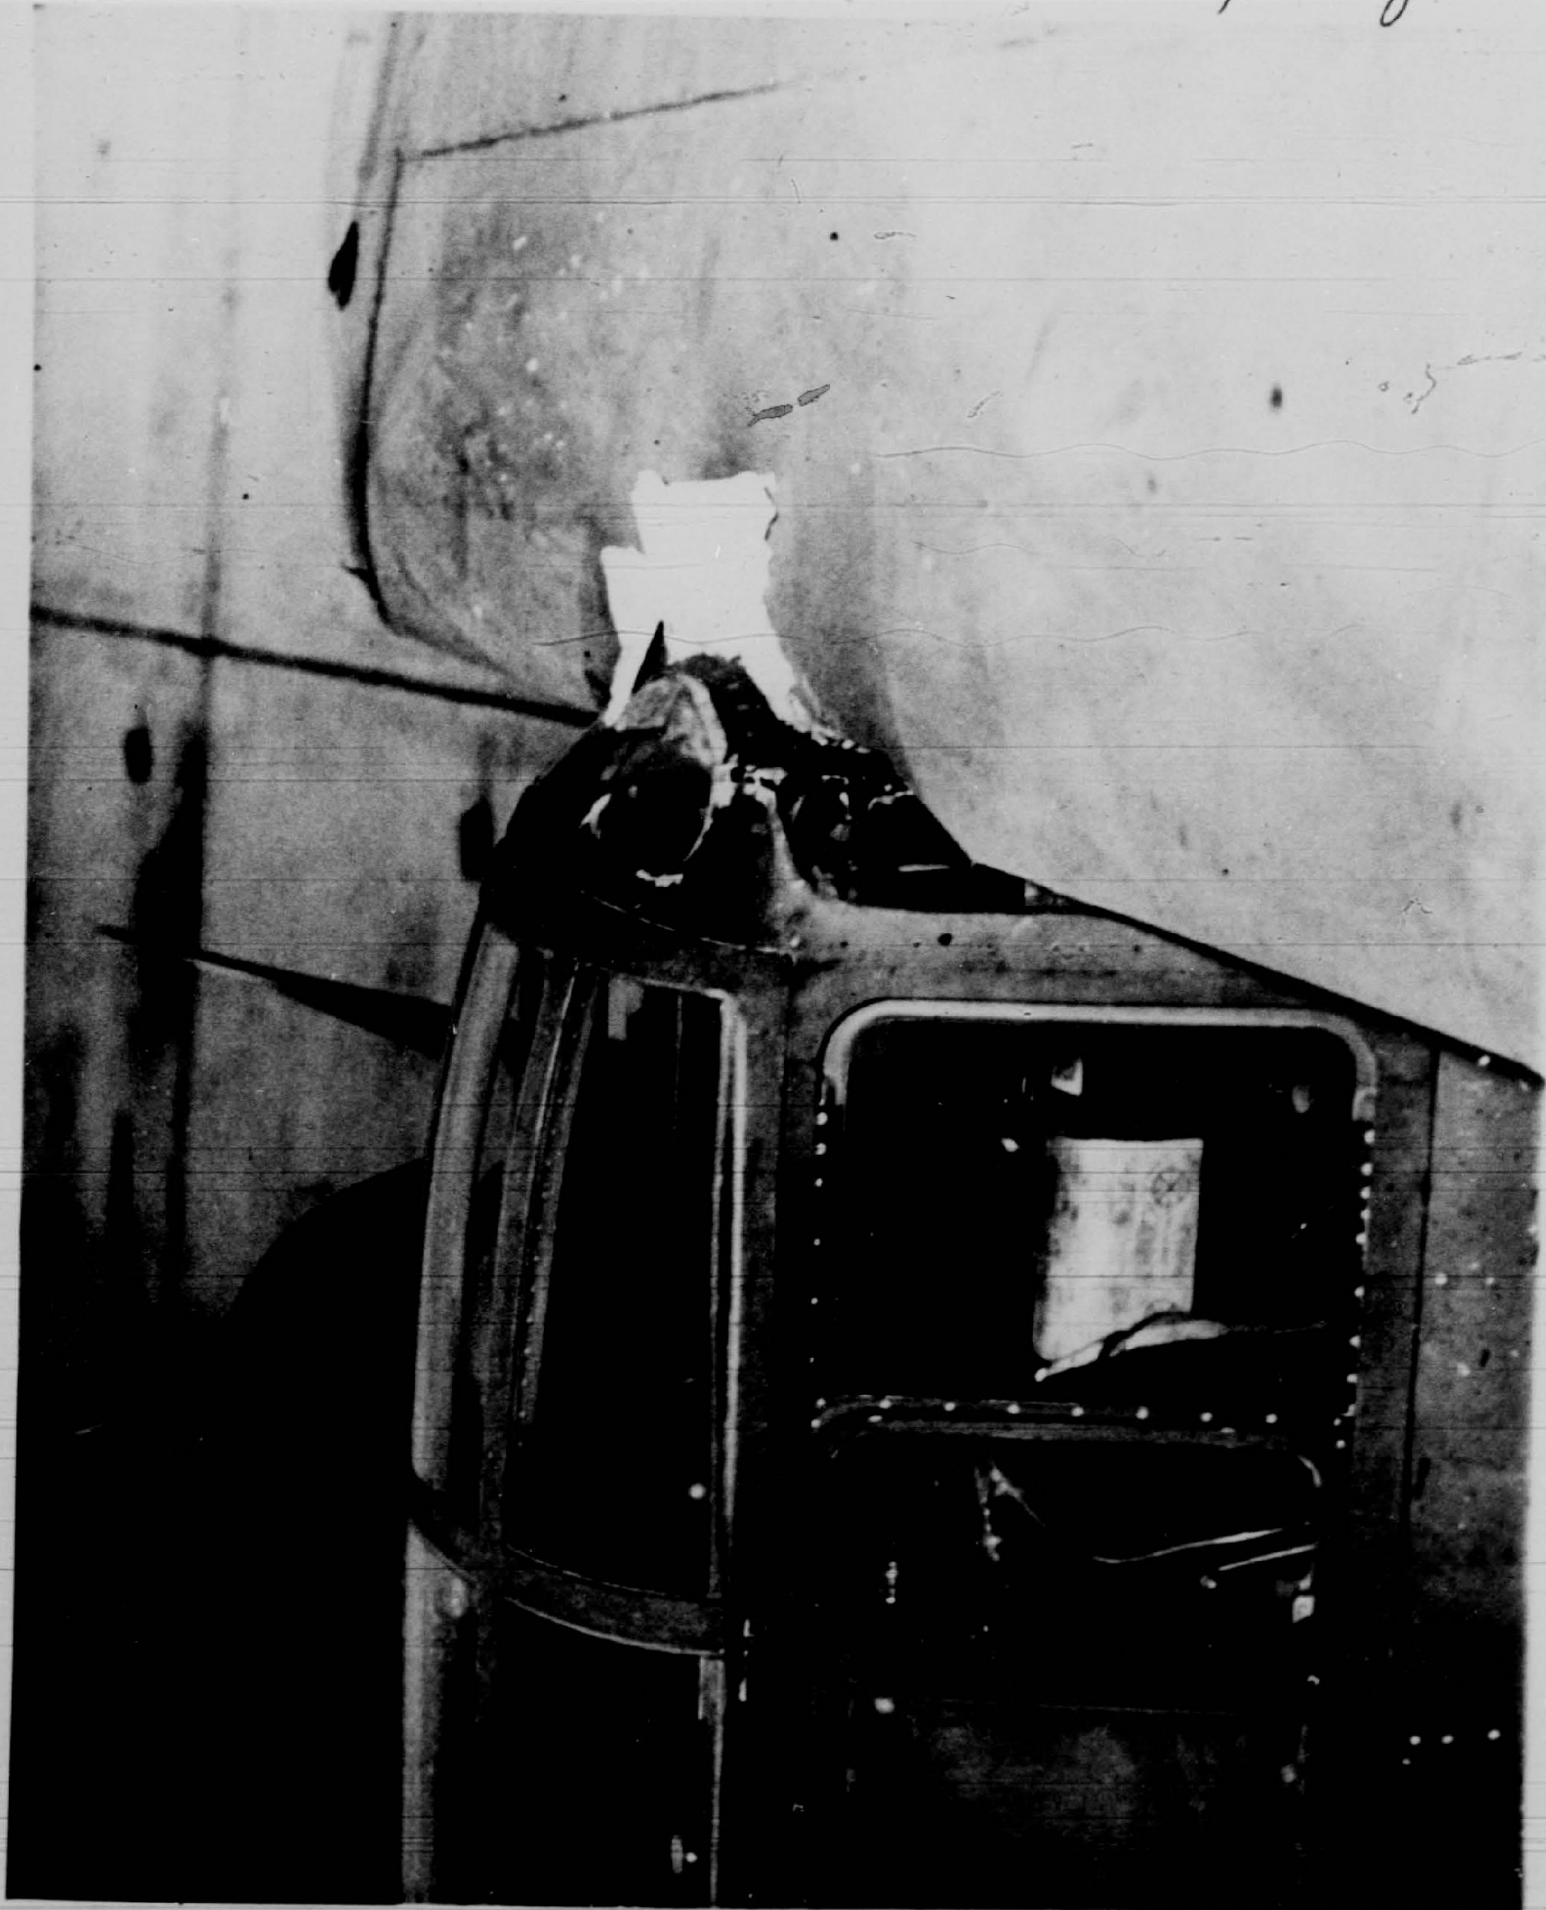
DAMAGE	(49) LIST OF DAMAGED PARTS
(46) Aircraft <u>Major</u>	<u>Extensive damage to right outer wing panel; extensive damage to windshield assembly; moderate damage to nose section.</u>
(47) Engine(s) <u>None</u>	
(48) Propeller(s) <u>None</u>

- Incl 1 - WD AAF Form #14 re A-20G-20, AC serial #286624.
- Incl 2 - WD AAF Form #14 re A-20G-20, AC serial #286582.
- Incl 3 - Statement of Crewman charged with accident.
- Incl 4 - Close-up of wing panel and nose section.
- Incl 5 - Close-up of two damaged airplanes.
- Incls 6 & 7 - Interior views of two cockpits.
