WAR DEPARTMENT
Barksdale Field, Louisiana
ARMY AIR FORCES
REPORT OF AIRCRAFT ACCIDENT

(1) Place Barksdale Field, Louisiana (2) Date 27 June 1944 (3) Time 16:35
 AIRCRAFT: (4) Type and model A-26B 020 (5) A. F. No. 41-39121 (6) Station Barksdale Field, La.
 Organization: (7) 3rd BC & 3rd AF (8) Barksdale RTU (1st) (9) Squadron "P"
 (Command and Air Force) (Group) (Squadron)

AIRCRAFT DAMAGE REPORT NO. 44-84

AIRPLANE: A-26B, AAF, 41-39121, Engines, Type R-2800-27, #1. FP 020035
#2. FP 020040

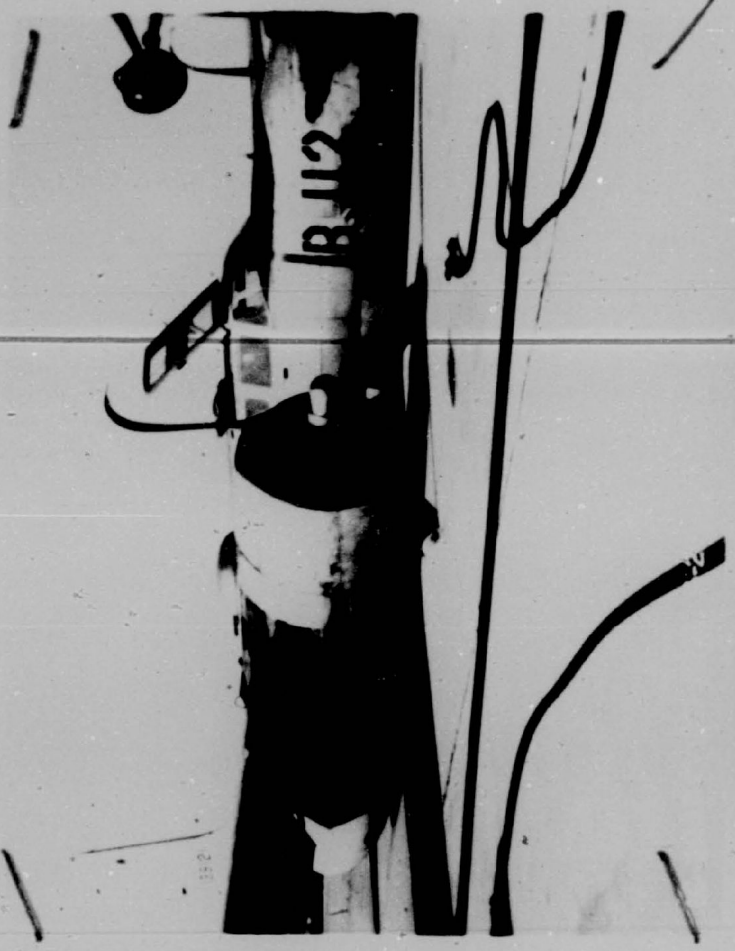
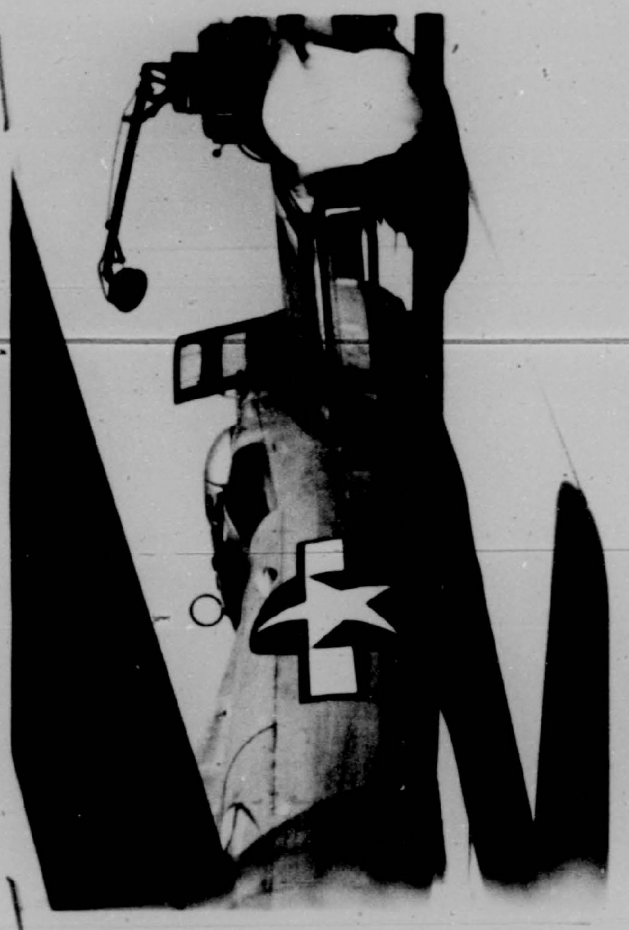
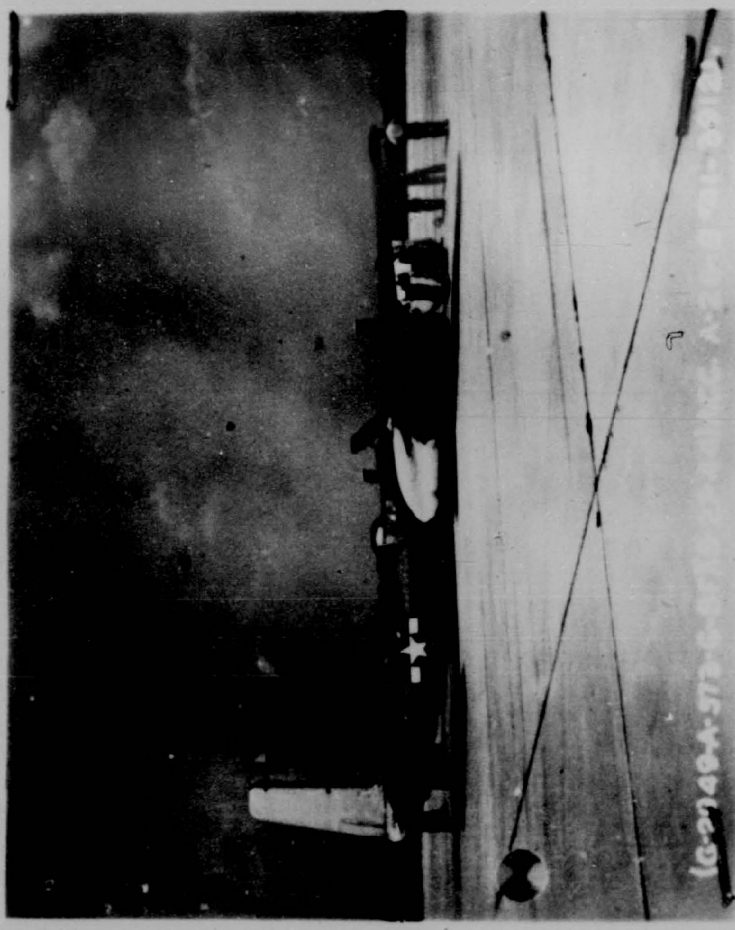
Photographs.

1. Airplane was damaged while making wheel up landing at this station on June 27, 1944. The following damage resulted.

- a. All blades bent on left propeller.
- b. All blades bent on right propeller.
- c. Skin sheared off bottom of bombay doors.
- d. Nose wheel and left main gear nacelle doors damaged.
- e. Bulkhead and skin between stations 240 and 280 damaged.
- f. Bottom of power gun turret damaged.
- g. Lower cowl flaps on both engines sheared off.
- h. Bulkhead between stations 70 and 105 buckled.
- i. Both engines to be replaced in accordance with T.O. 02-1-15.

2. Recommendations: Airplane to be repaired by 8th Sub-Depot.
