**REPORT OF AIRCRAFT ACCIDENT**

(1) Place Station A-55 (2) Date 25 November 1944 (3) Time 1650  
 AIRCRAFT: (4) Type and model A-26B-20 (5) A. F. No. 41-39188 (6) Station Station A-55  
 Organization: (7) 9th B.D., Ninth AF (8) 416th Bomb (L) (9) 668th Bomb (L)  
 (Command and Air Force) (Group) (Squadron)

(1) Place STATION A-55 (2) Date 25 NOVEMBER 1944 (3) Time 1650  
 Aircraft: (4) Type and model A-26B-20 (5) A. F. No. 41-39264 (6) Station A-55  
 Organisation: (7) 9TH B.D. NINTH AF (8) 416TH BOMB (L) (9) 668TH BOMB (L)  
 (Command and Air Force) (Group) (Squadron)

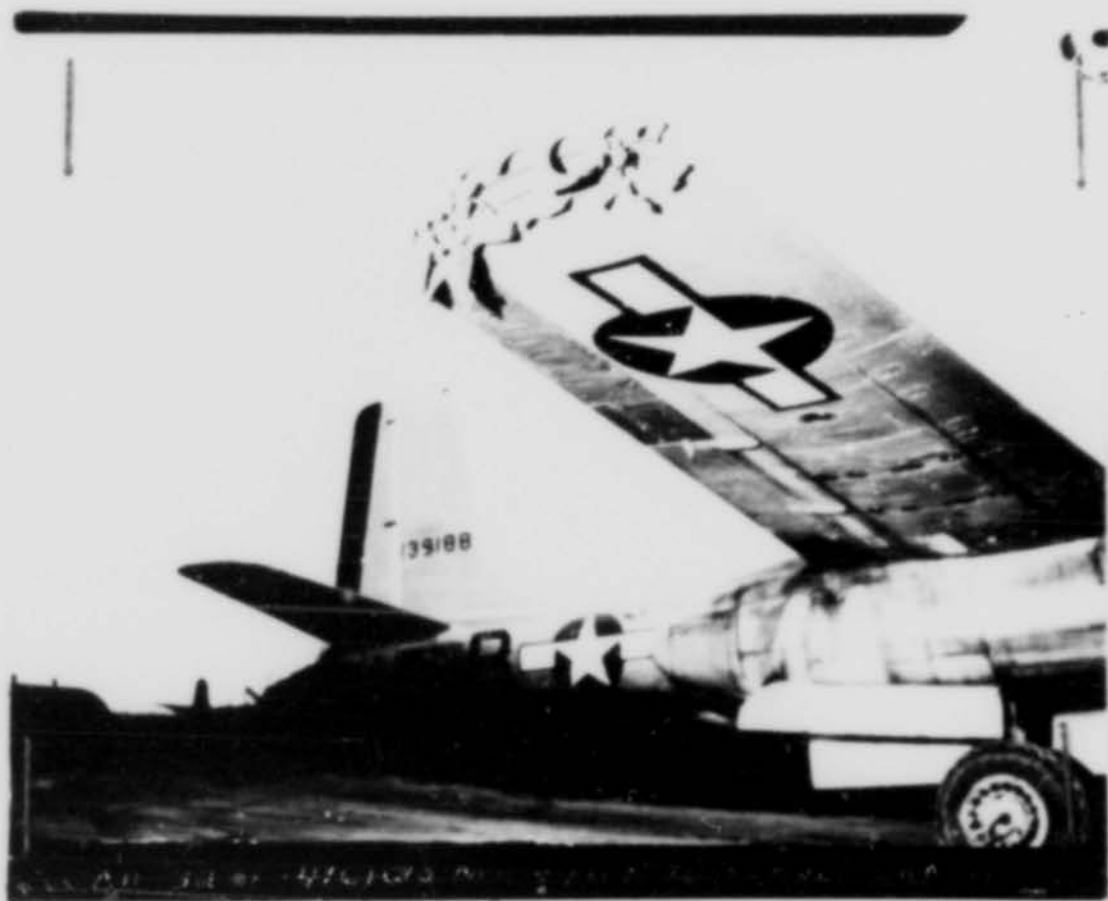
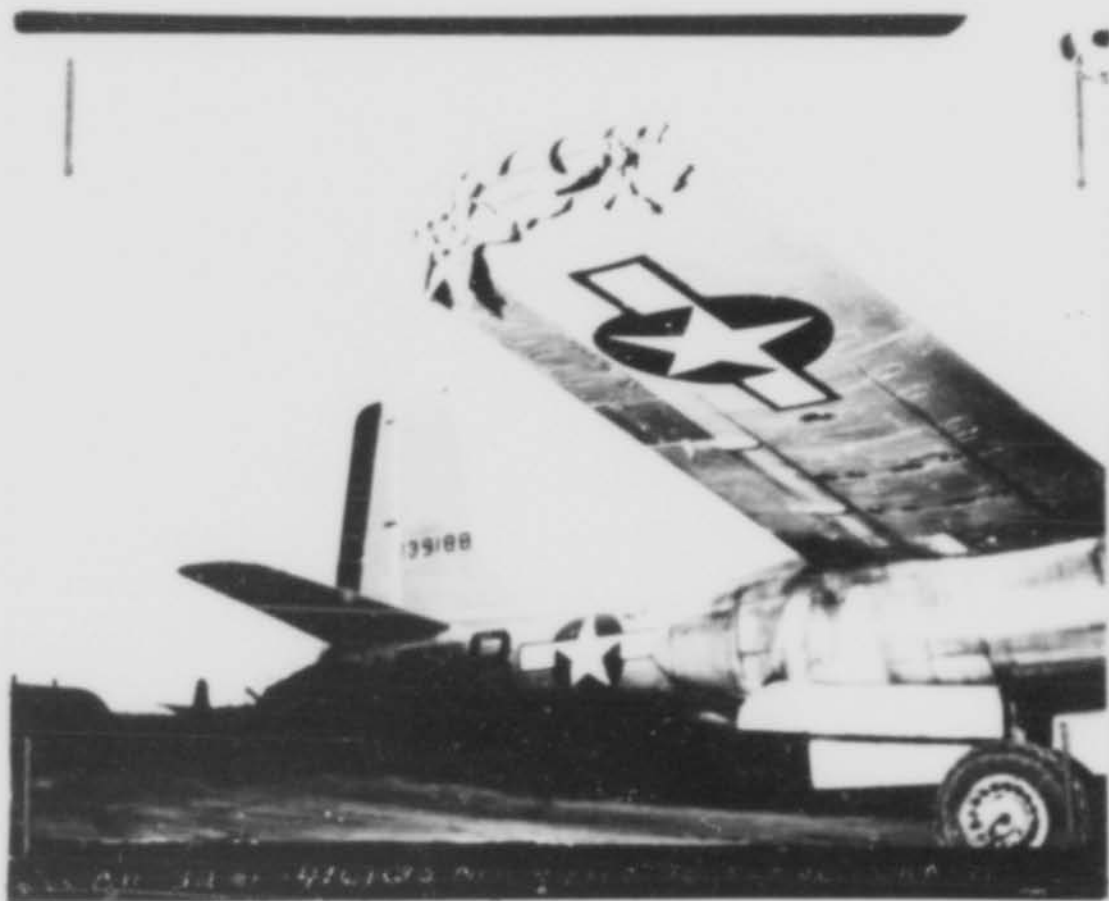
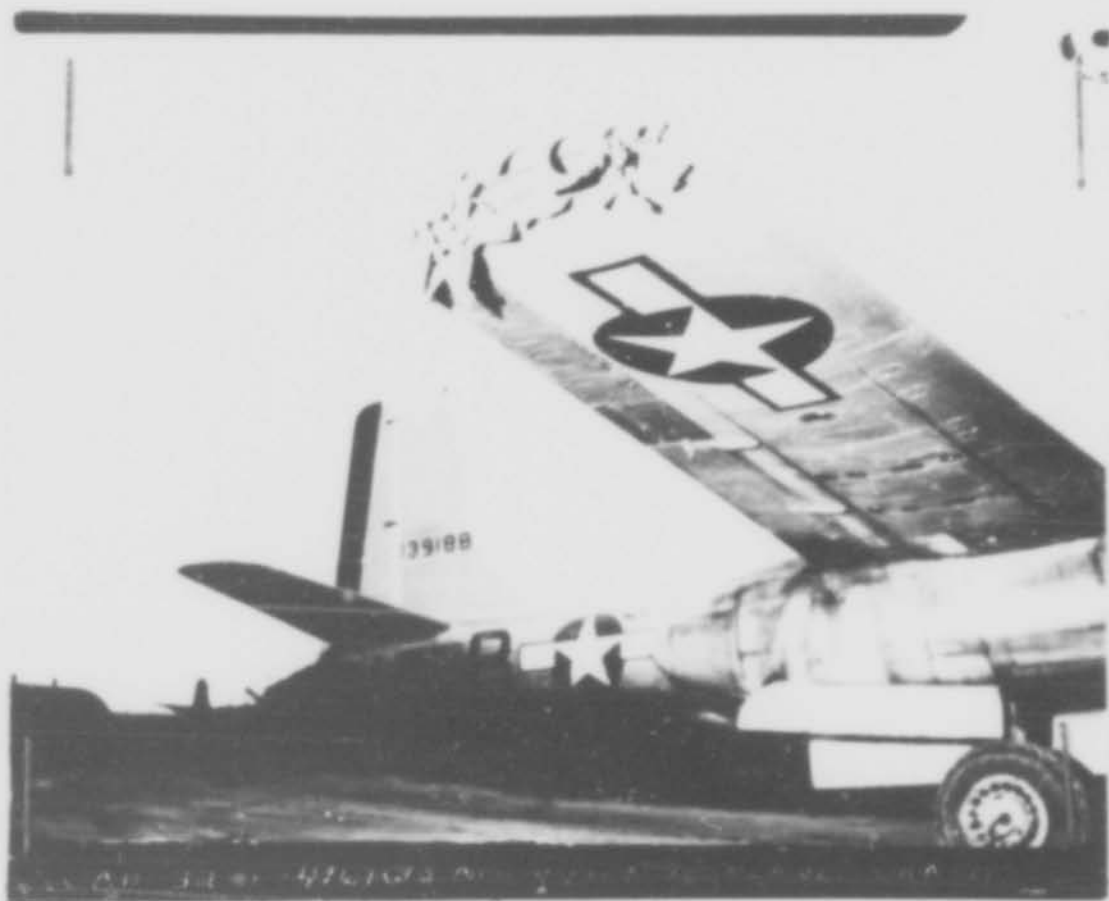
Incl. 6

DAMAGE	(49) LIST OF DAMAGED PARTS
(46) Aircraft <u>03</u>	Damage to right wing. Right aileron.
(47) Engine(s) <u>1</u>	
(48) Propeller(s) <u>0</u>	Right propeller.

On 25 November, 1944, at 1650 hours, Lt. Carver was taxiing to take-off position for a routine transition flight. On the single lane perimeter strip he encountered another aircraft taxiing the opposite direction. Lt. Roberts, the pilot of the other aircraft, pulled off into a roadway as far to the side as possible. Lt. Carver decided that he had room to pass and he proceeded. Lt. Roberts saw that the planes would not clear, and cut his right engine. However, the right wing of Lt. Carver's airplane contacted the right propeller of Lt. Robert's airplane before the propeller had stopped rotating. Approximately eighteen inches, of the right wing tip were cut off, the right aileron and right propeller were damaged on Lt. Carver's airplane. The right propeller of Lt. Robert's airplane was damaged.

My right wing was damaged, the propeller of the other aircraft having removed approximately eighteen inches of its tip. The right aileron was damaged and one blade of the right prop severely nicked, having been hit by an inspection plate, off the wing tip, flying into it. The other aircraft had all three blades of the propeller damaged severely.

Whenever there is a question as to whether a taxiing aircraft will clear an obstruction, pilots should not proceed until they can receive visual signals from responsible personnel on the ground.

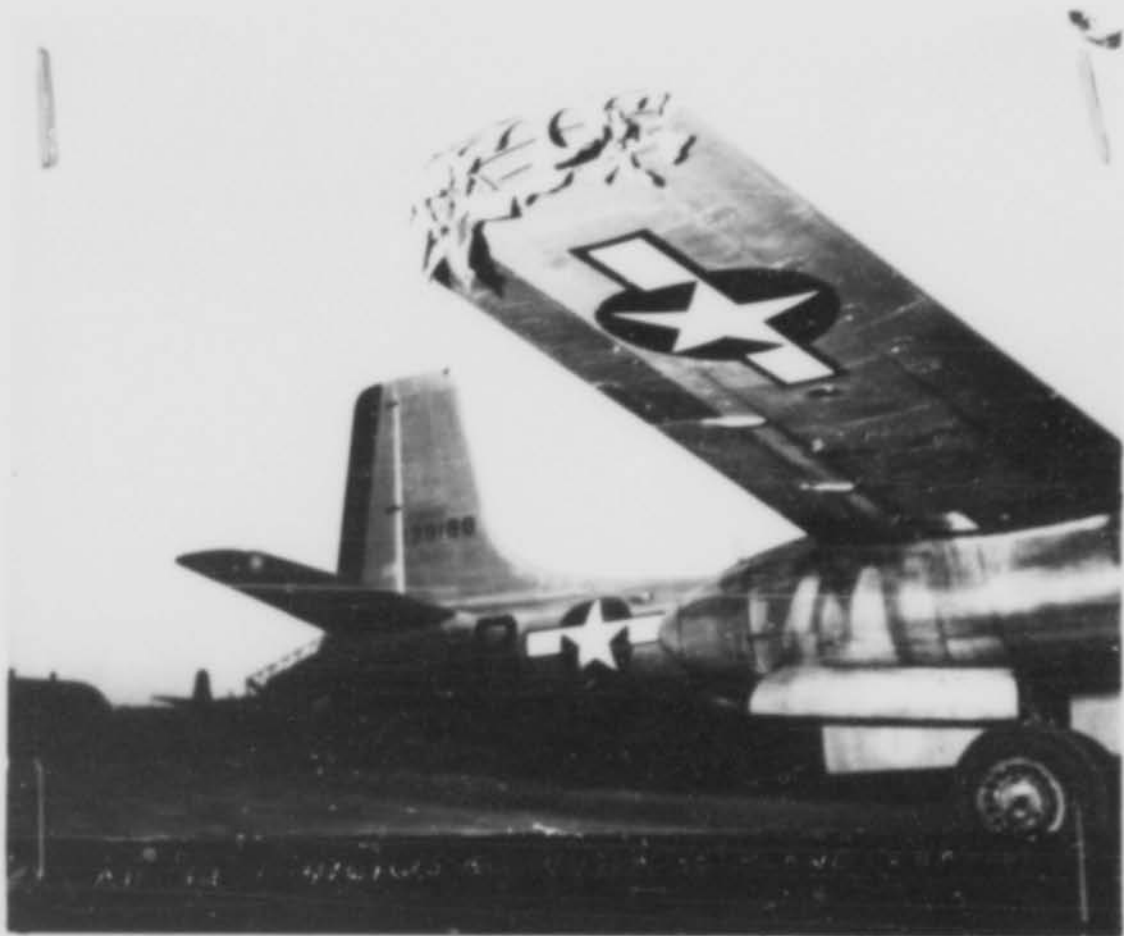
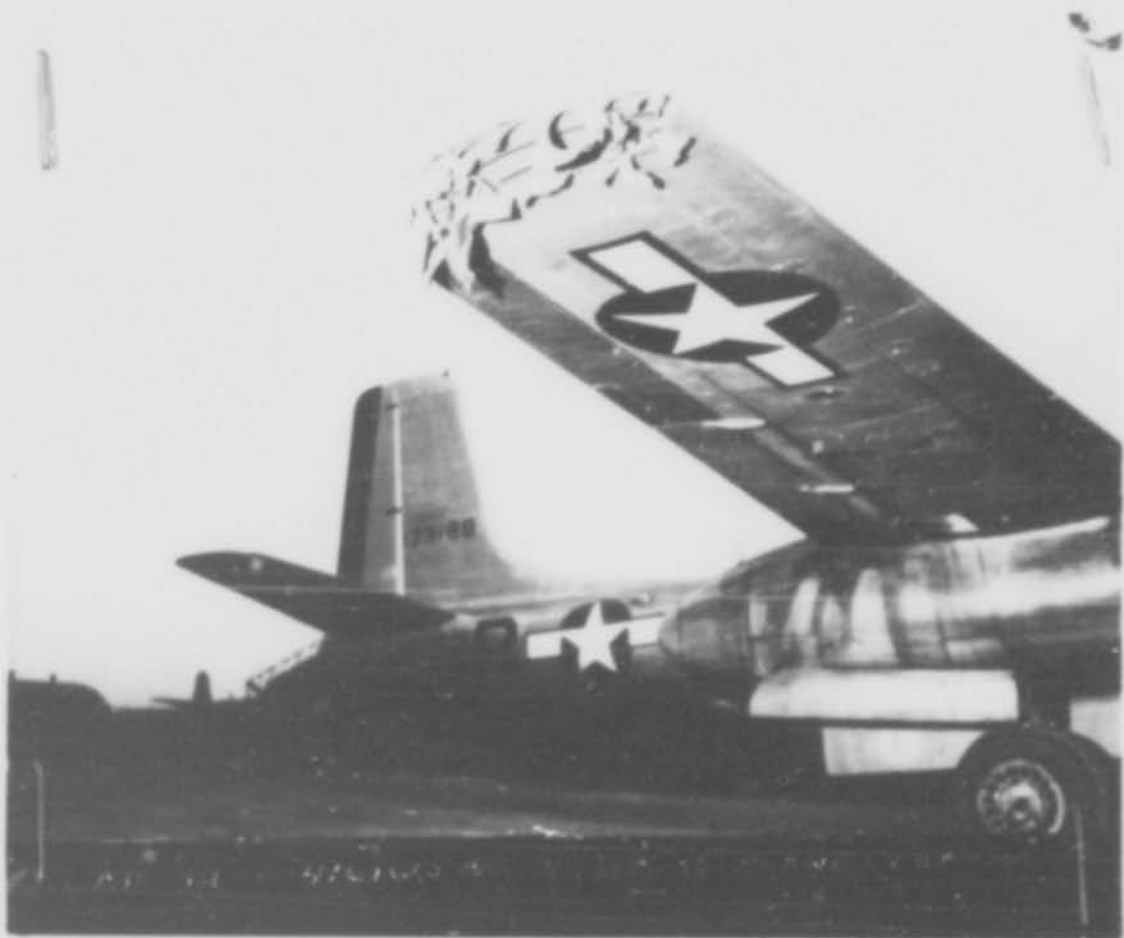
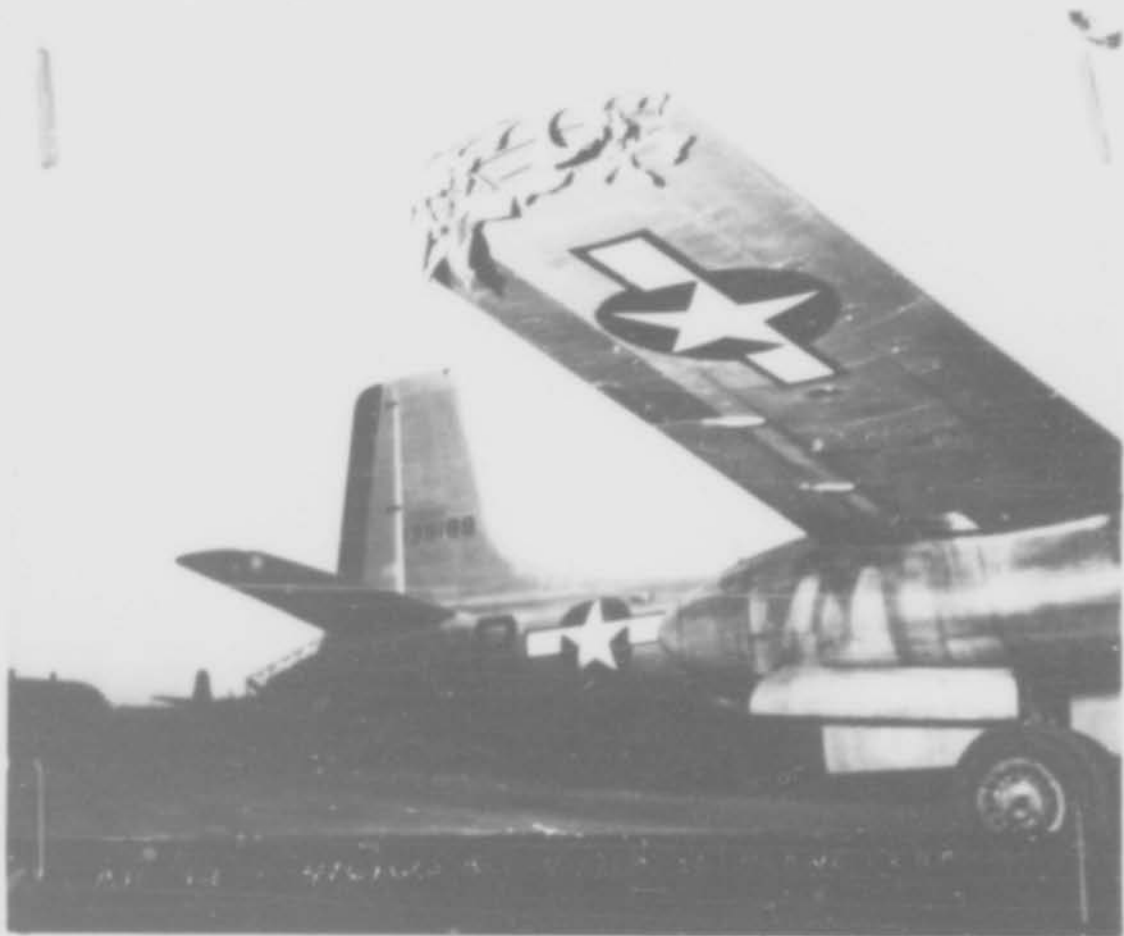
and # 6

DAMAGE	(46) LIST OF DAMAGED PARTS
(46) Aircraft	
(47) Engine(s)	
(48) Propeller(s)	RIGHT PROPELLOR

On 25 November, 1944, at 1650 hours, Lt Roberts was taxiing back to the squadron area after completing a routine training flight. On the single lane perimeter strip he encountered another aircraft, piloted by Lt. Carver, taxiing in the opposite direction. Lt. Roberts pulled off to the left into a roadway as far as possible and stopped his aircraft. As the other aircraft taxied forward Lt. Roberts saw that it would not clear, and he unsuccessfully attempted to signal the other pilot. When he saw that collision was inevitable, Lt. Roberts cut the mixture control on his right engine. However the propeller was still rotating when the wingtip of the other aircraft contacted it. The right propeller of Lt. Roberts' airplane was damaged, and the right wing tip, right aileron, and right propeller of Lt. Carver's airplane were damaged.

As the aircraft moved forward, I cut the mixture control of my right engine but did not cut it in time to prevent damage to the right wing of the other aircraft. I cut my left engine and left my aircraft to inspect the damage. My right propeller was badly nicked on all three blades requiring a propeller change. Apparently no damage was done to the engine.

Wherever there is a question as to whether a taxiing aircraft will clear an obstruction, pilots should not proceed until they can receive visual signals from responsible personnel on the ground.
