REPORT OF AIRCRAFT ACCIDENT

(1) Place Station A-55 (2) Date 4 December 1944 (3) Time 1410
 AIRCRAFT: (4) Type and model A-26B-15 B0 (5) A. F. No. 42-22220 (6) Station A-55
 Organization: (7) 9th ED Ninth AF (8) 416th Bomb (L) (9) 670th Bomb (L)
 (Command and Air Force) (Group) (Squadron)

(56) Nature of accident landing accident.

(57) Cause of accident Unserviceable runway caused crosswind landing on wet runway under adverse weather conditions.

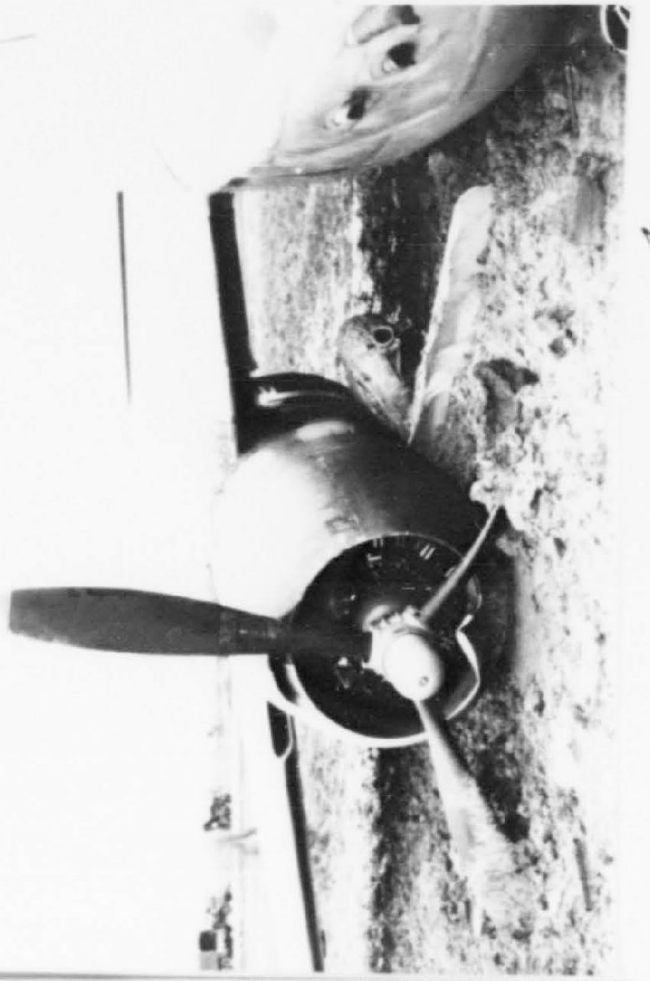
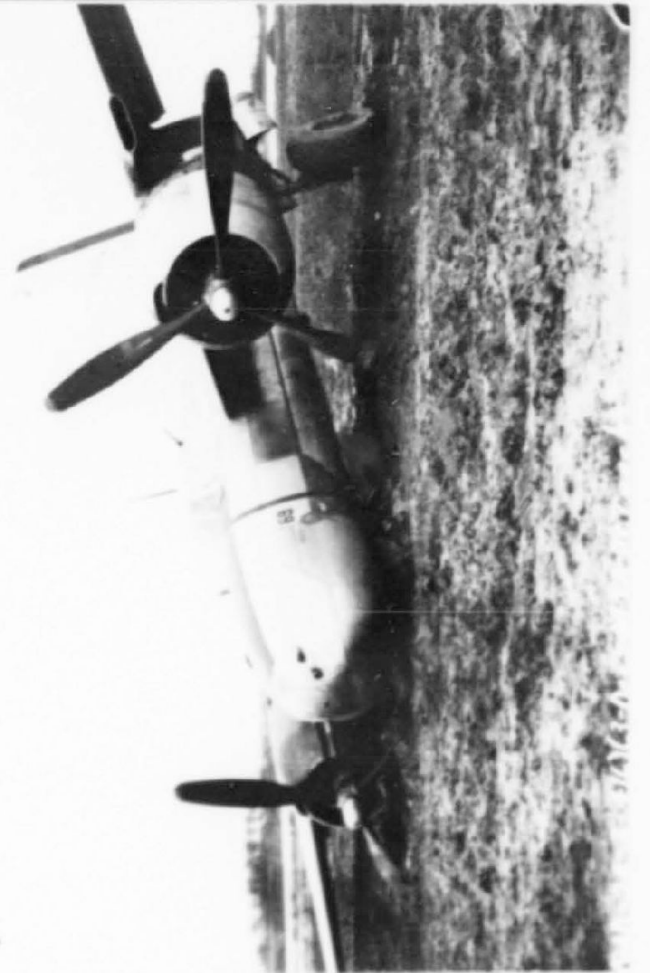
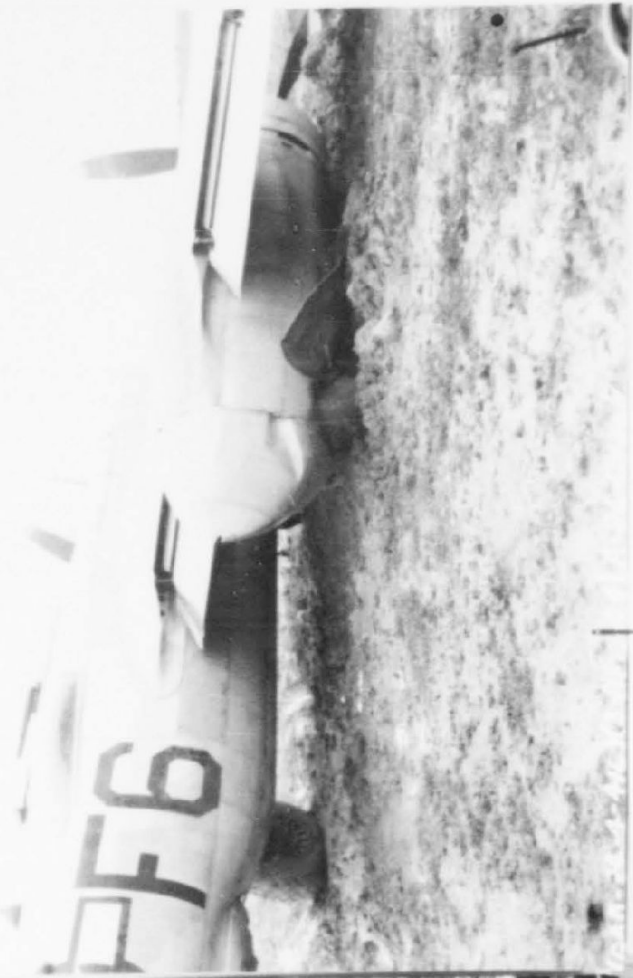
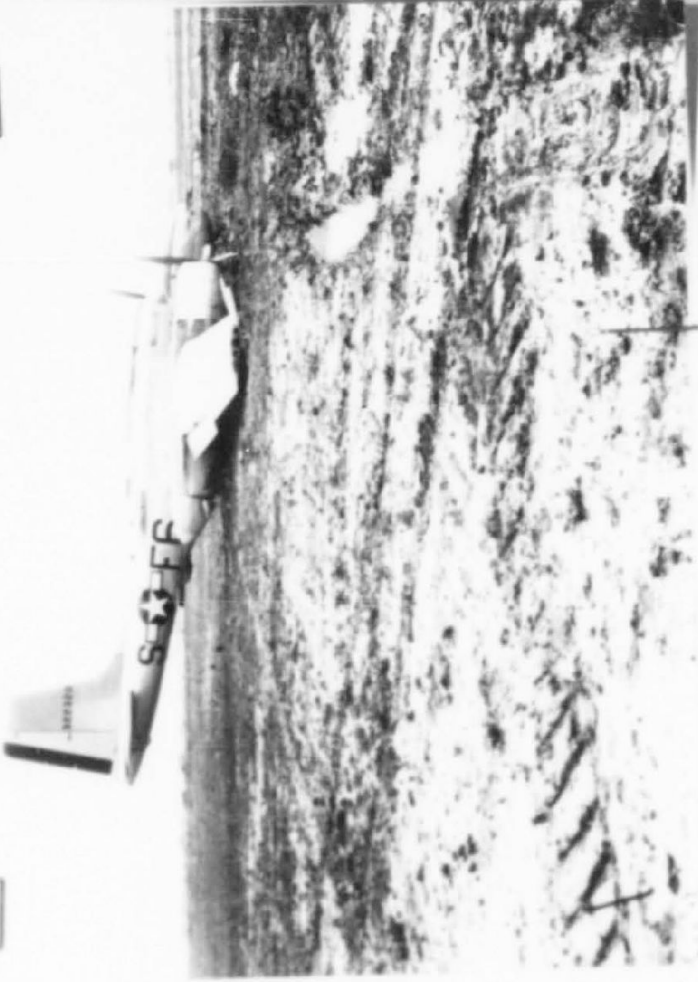
Incl. #7

DAMAGE				(49) LIST OF DAMAGED PARTS
(46) Aircraft	0	2		Rt. Wing tip, nose wheel doors, rt. nacelle, lower turret
(47) Engine(s)	0	3		Rt. engine sudden stoppage
(48) Propeller(s)	0	3	0.3	Both propellers

Captain Monroe took off at approximately 1400 for the purpose of checking the hydraulic system of aircraft A-26B-15 number 43-22320. Soon after takeoff, he was recalled because of a sudden rain shower. There was a strong wind, and the runway into the wind was unserviceable. However, weather conditions necessitated an immediate landing at this base. Consequently, Captain Monroe used only half flaps, and made his landing in the strong crosswind. He made a normal approach and a normal landing on the first third of the runway. However, the runway was wet and very slippery. When he applied brakes, they did not hold. Consequently, he skidded off the end of the runway. The right wheel sank into the mud, and then hit solid gravel of a filled in hole. The right main gear drag strut brace broke, and the gear collapsed. Meanwhile, the airplane swung to the right, and the nose wheel hit a hole while sliding sideways. Consequently, the nose wheel fork broke off at the shock strut piston.

The right wing tip was damaged, and both propellers were damaged. The right nacelle and the nose wheel doors were also damaged. Only the right engine had sudden stoppage. The lower turret was damaged. The aircraft is repairable.

Pilots be cautioned that, when it is necessary to land an aircraft under the conditions herein described, they use all available means to slow the aircraft as much as possible. This should include cutting mixture controls, dropping full flaps, and opening cowl flaps immediately after landing.
