ACCIDENT No. 45-1-25-516

REPORT OF AIRCRAFT ACCIDENT

(1) Place Station A-55 (2) Date 25 January 1945 (3) Time 1746
AIRCRAFT: (4) Type and model A-26B-25 (5) A. F. No. 42-39349 (6) Station A-55
Organization: (7) 9th ED Ninth AF (8) 416 Bomb (L) (9) 668 Bomb (L)
(Command and Air Force) (Group) (Squadron)

(56) Nature of accident landing accident. wheels up landing. 4G

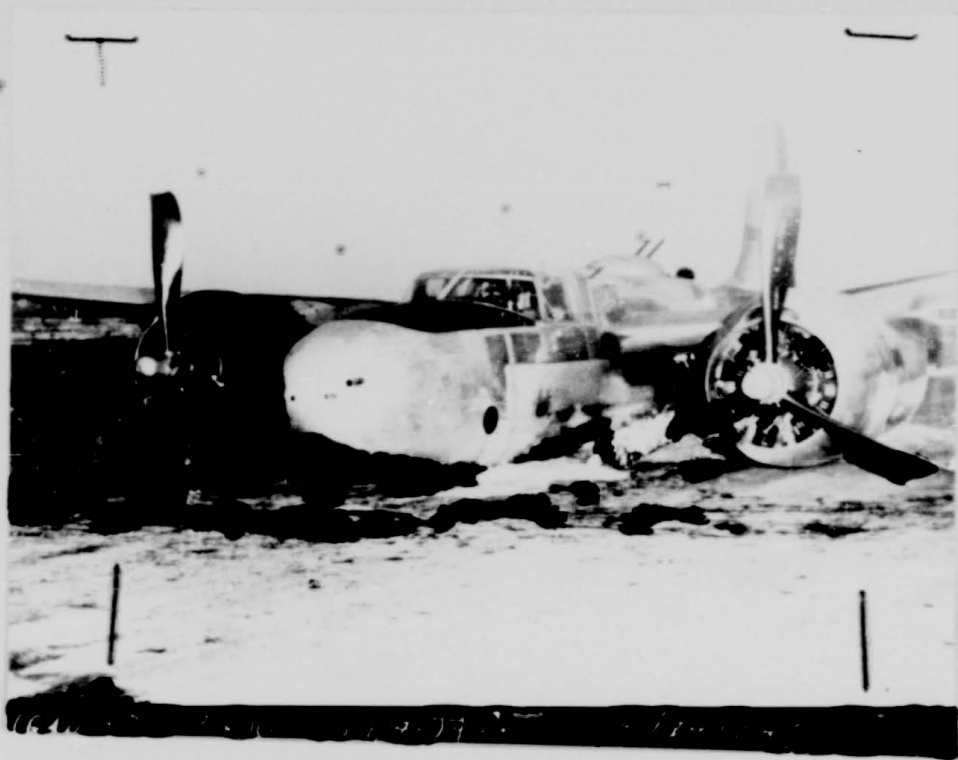
Encl #8

Investigation disclosed that the main actuating cylinder had been sheared from the support assembly, main landing gear upper retracting link. This could have been caused only by some externally applied force which pushed the landing gear beyond its limit.

A two foot bank of snow borders the sides of the runway. The airfield controller reported that the left gear of Lt. Hale's aircraft hit this bank of snow just after take-off. With the gear in the process of retracting, it would not have taken much force to so increase the momentum of the gear that the failure could occur. Consequently it is believed that, when the retracting gear contacted the snow bank, the landing gear was forced beyond its limit and hit the top of the nacelle.

Investigation of the accident which occurred on A-26E aircraft AAF No 41-39349 on which the left main landing gear failed to extend, revealed that the main actuating cylinder had sheared from the support assembly, main landing gear upper retracting link. This prevented the actuating cylinder from releasing the up lock and as no emergency system is provided, a belly landing resulted. It was also noted that the support assembly, main landing gear upper retracting link forging had been broken in half. It is my belief that some force was placed on the landing gear during the retracting process which forced the landing gear beyond its limit and consequently it hit the top of the nacelle. The skin on top of the nacelle was missing after landing and also one former was torn out and one bent.

On any cross-wind take-off extreme care must be exercised by the pilot to insure that any drift is killed during and immediately after the take-off run. This is especially applicable when there are obstructions to the side of the runway.
