RESTRICTED
WAR DEPARTMENT
STATION 1-69
U. S. ARMY AIR FORCES
REPORT OF AIRCRAFT ACCIDENT

A 6 ACCIDENT No. _____
45-5-17-521
H.B. 400j.45

(1) Place Station A-69 (2) Date 17 May 1945 (3) Time 0010 7
AIRCRAFT: (4) Type and model A-26B-20 Bo (5) A. F. No. 41-39210 (6) Station A-69
Organization: (7) 9 AD Ninth AF (8) 416 Bomb (L) (9) 671 Bomb (L)
(Command and Air Force) (Group) (Squadron)
PERSONNEL BK Y 300

(56) Nature of accident Night landing accident. **4 397**

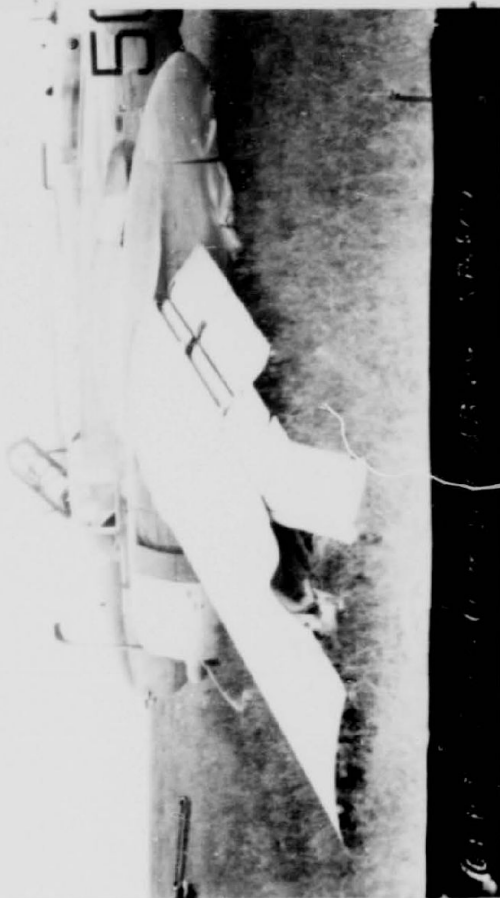
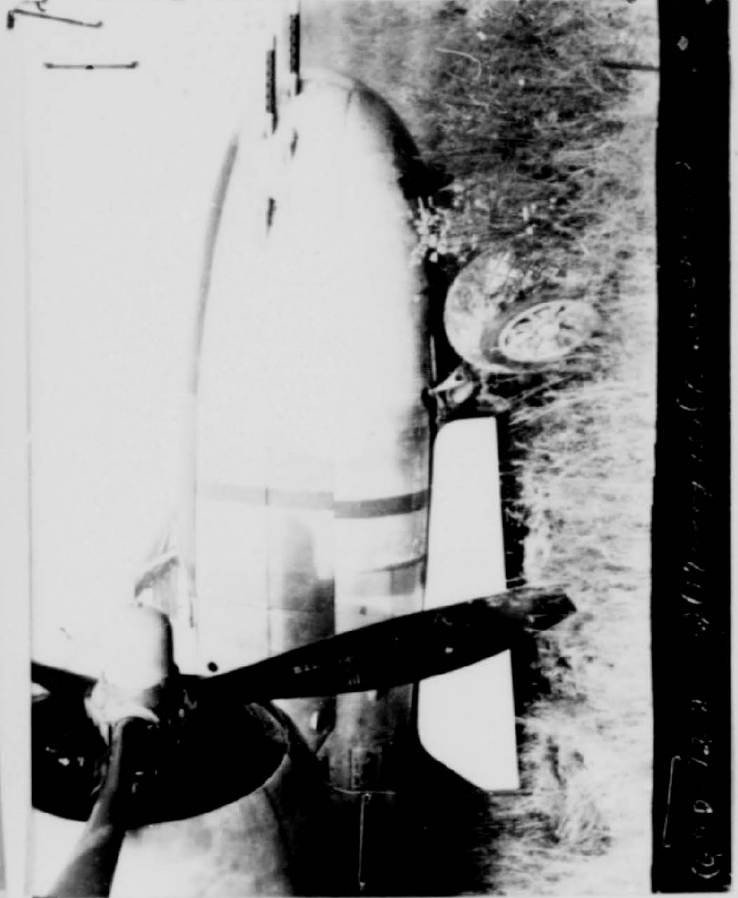
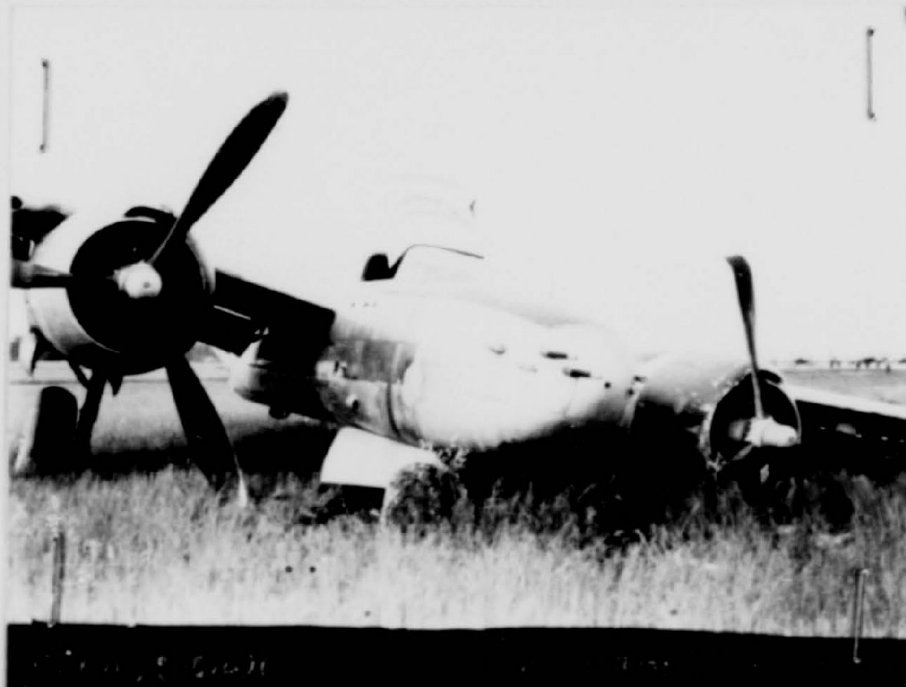
Incl. 9 + 10

(57) Cause of accident Collapse of left main gear shortly after touching down. **60 Green**

Immediate Cause: Collapse of left main gear shortly after touching down during a night landing.

Underlying Cause: Failure of left main gear to lock in extended position.

#2 - Left Gear retracted on landing-wing tip-left prop-nose gear all damaged - DA Fero, 1st Lt., Air Corps.
