ACCIDENT NO. 45-6-16-512

**REPORT OF AIRCRAFT ACCIDENT**

(1) Place Station A-89 (2) Date 16 June 1945 (3) Time 2015  
 AIRCRAFT: (4) Type and model A-26B-15 (5) A. F. No. 43-22383 (6) Station A-59  
 Organization: (7) 9AD Ninth AF (8) 416 Bomb (L) (9) 669 Bomb (L)  
 (Command and Air Force) (Group) (Squadron)

(57) Cause of accident Material failure - overtravel of main landing gear latch assembly on left main gear.

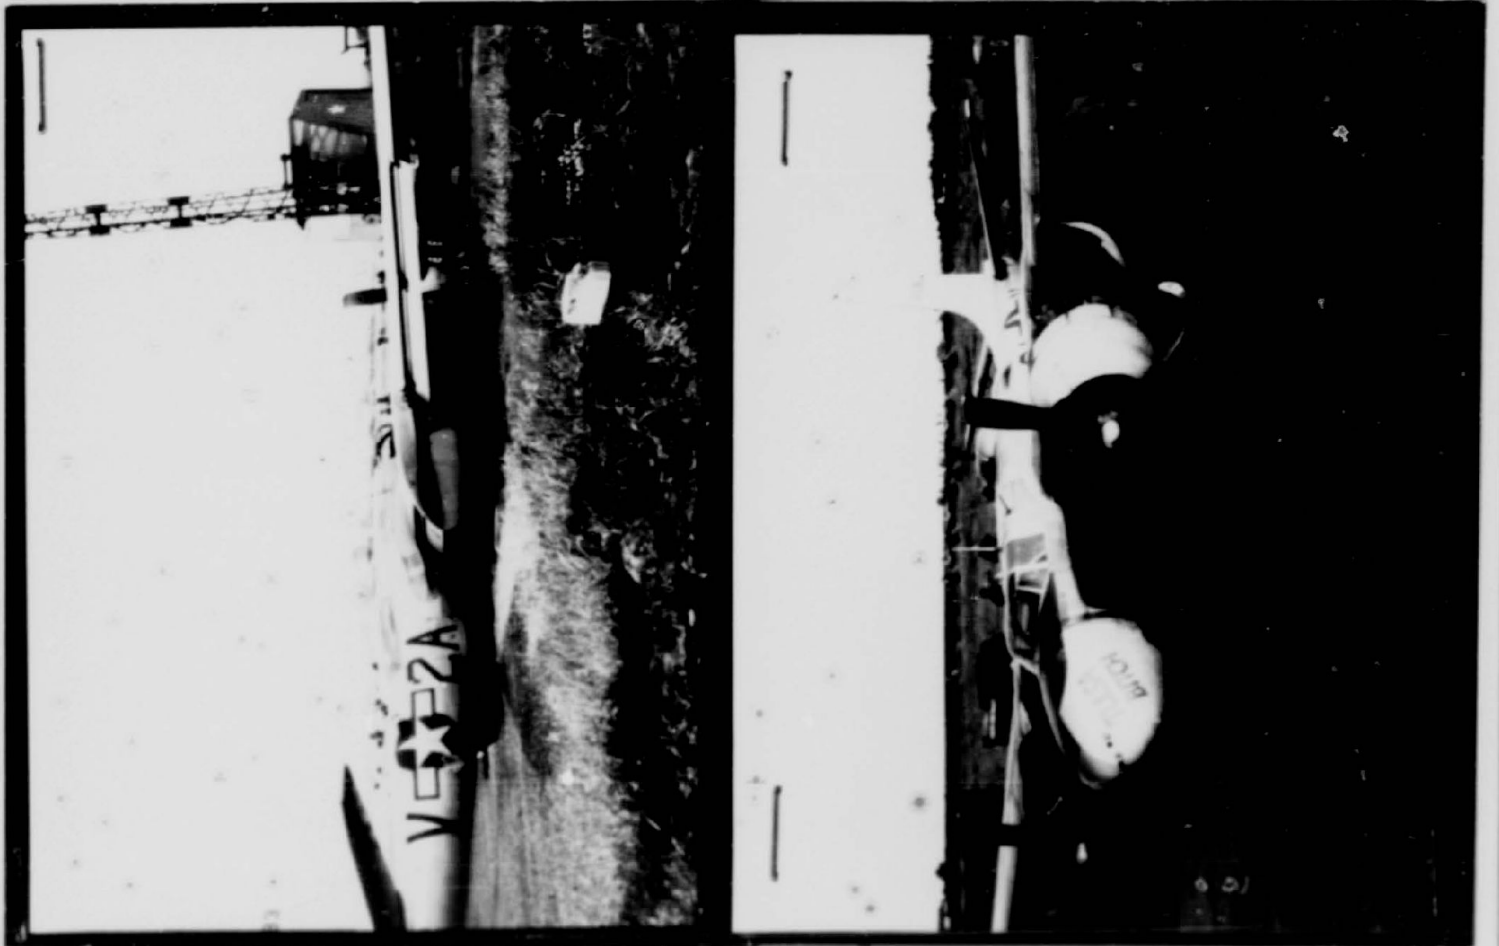
DAMAGE		Description
(46)	(47)	
(46) Aircraft	0	Bomb Bay Doors, Bomb Door Spoilers, Pilot and Gunners Hatch, Bottom Gun Turret, Lower Sighting Station, Rear Fuselage, Left horizontal stabilizer dented, sudden stoppage both engines, both nacelles, both props bent.
(47) Engine(s)	0 0	
(48) Propeller(s)	0 0

UNDERLYING CAUSE: Failure of left main gear to extend due to overtravel of main landing gear latch assembly.

- a. It is recommended that a bungee be installed on the main landing gear similar to the installation on A-20 series aircraft, which will prevent retraction of the landing gear before the locks are lifted.
- b. That the unlocking mechanism be made heavier to prevent stretching of Rod Assembly. 455
- c. That a manual means for lifting the locks be installed which is similar to the method used on A-20 series aircraft.
