45-8-11-520-1

REPORT OF AIRCRAFT ACCIDENT

AIRCRAFT: (4) Type and model A-20G-25 (5) A. F. No. 43-9568 (6) Station AAF Station 170

(57) Cause of accident Left main landing gear collapsed on landing.

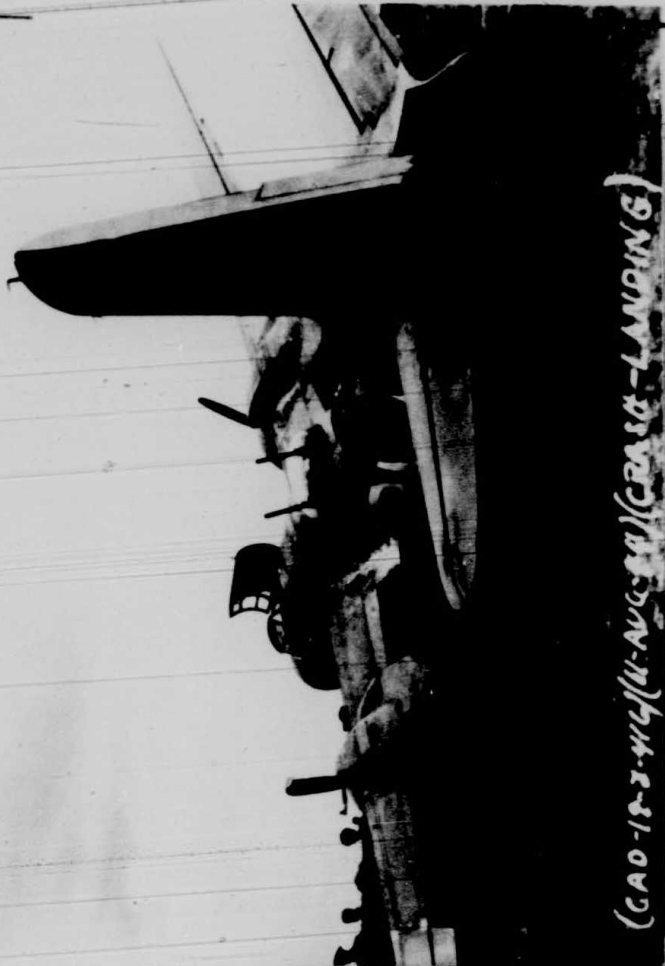
(GAO-19-2-414) (11-AUG-49) (CRASH-LANDING)

Investigation disclosed that the Lug Assembly of the Landing Gear Actuating Cylinder anchor had broken, causing the gear to collapse. The cause was materiel failure. (60)

Upon examination of A-20G-25 aircraft, AAF serial No 43-9368, following its landing accident on AAF Station 170 at 1340, 11 August 1944, it was discovered that the left main landing gear had collapsed due to a materiel failure of the landing gear actuating cylinder anchor lug assembly, Part No 1066938.
