DESCRIPTION OF ACCIDENT

While taking off on an operational mission in aircraft A-26B No. 301, 2 January 1945, Lt. Clark crashed. Witnesses stated that although Lt. Clark cleared the ground and picked up his wheels, he was obviously having much difficulty holding his aircraft off the ground. A few hundred yards off the end of the runway he again hit the ground, slid along, hit a ditch which threw him a few feet into the air, and then crashed and exploded. When the aircraft exploded both crew members were killed.

Transmitted herewith is AAF Form 14 (in quadruplicate) with inclosures covering accident of Lt. Hiram B. Clark in aircraft A-26B-10 ACSN 43-22301 on 2 January 1945.

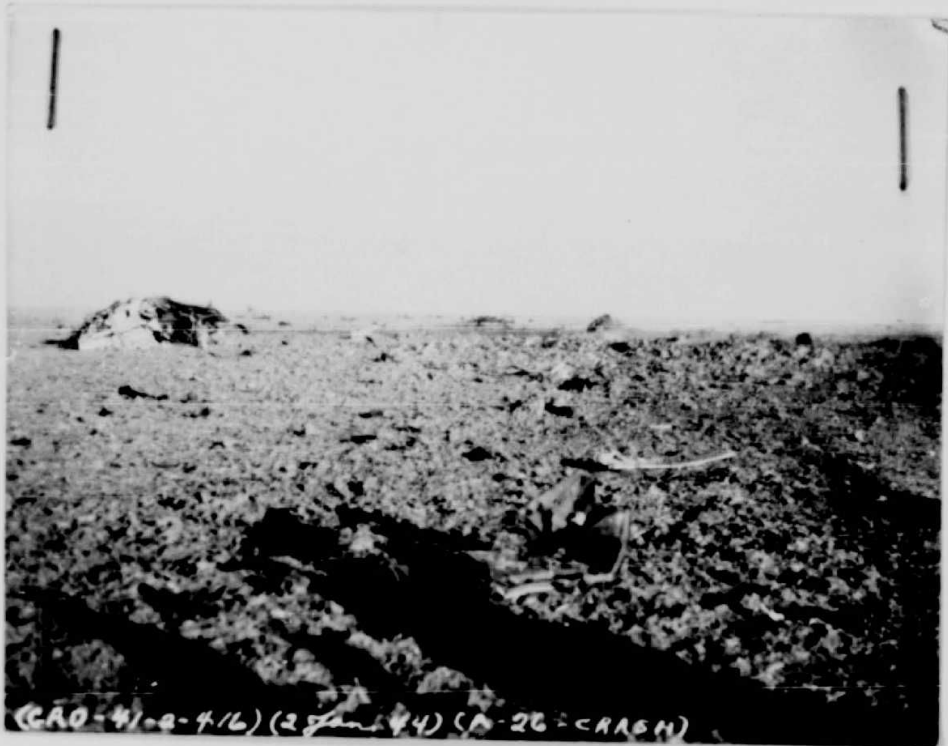
(GAO-41-9-416) (27 Jan 44) (A-26-CRASH)

- Weather. Unforeseen weather phenomena conducive to frost forming caused much frost to be formed on wings, fuselage, and cockpit glass between start engines and take off time. The rapidity of the forming of frost and the extent to which any frost formation influences the airfoil characteristics of the new laminar flow wing were greater than had been anticipated from past experience.

12. The Committee, after hearing all of the evidence, believed that visibility was not a main factor in the accidents. Icing and frost upon wings and propellers was felt to have been the main cause of the accidents. The frost and ice must have accumulated during the interval from "Kill-Frost" time at hard-stand to take-off time. This interval varied from 1 to 2½ hours.

- At any time that both fog and under-cooling temperature exist, extreme caution should be exercised in reaching a decision as to clearance of even an operational mission. This should include careful observation of any frost formation, and is particularly applicable when aircraft with the sensitive laminar flow airfoil section are concerned.

It is also recommended that some system or equipment be devised which will insure that any frost formed during taxiing will be removed prior to the take-off run.
