WAR DEPARTMENT
U. S. ARMY AIR FORCES
REPORT OF AIRCRAFT ACCIDENT

48-019
(1) Place Army Air Field, Lake Charles, La. (2) Date 25 Sept 43 (3) Time 0835 GMT
AIRCRAFT: (4) Type and model A-20C-15 (5) A. P. No. 42-51347 (6) Station AAF, Lake Charles, La.
Organization: (7) 3rd Bomb. Comd. (8) 116th Bomb. (Group) (9) 668th Bomb. (Squadron)
3 3B PERSONNEL BLL BLL 8860

DESCRIPTION OF ACCIDENT

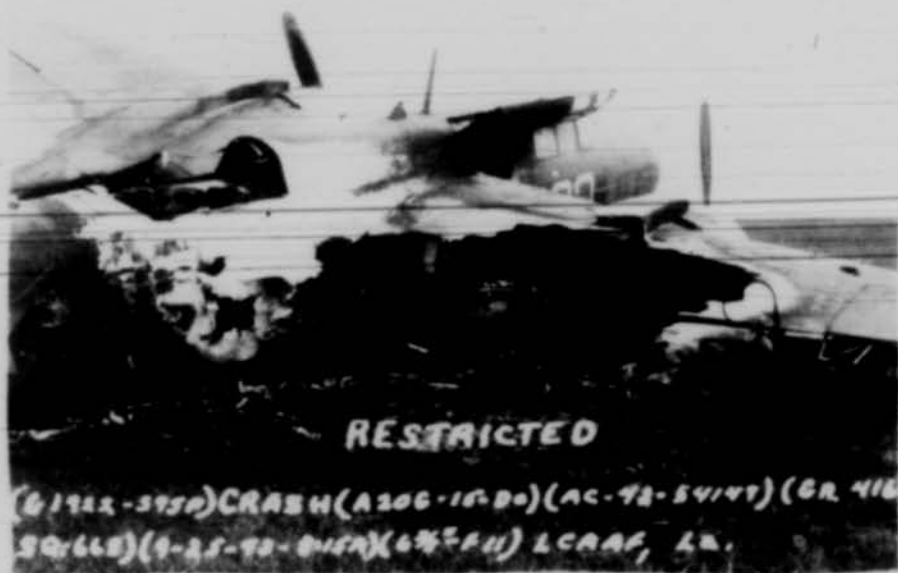
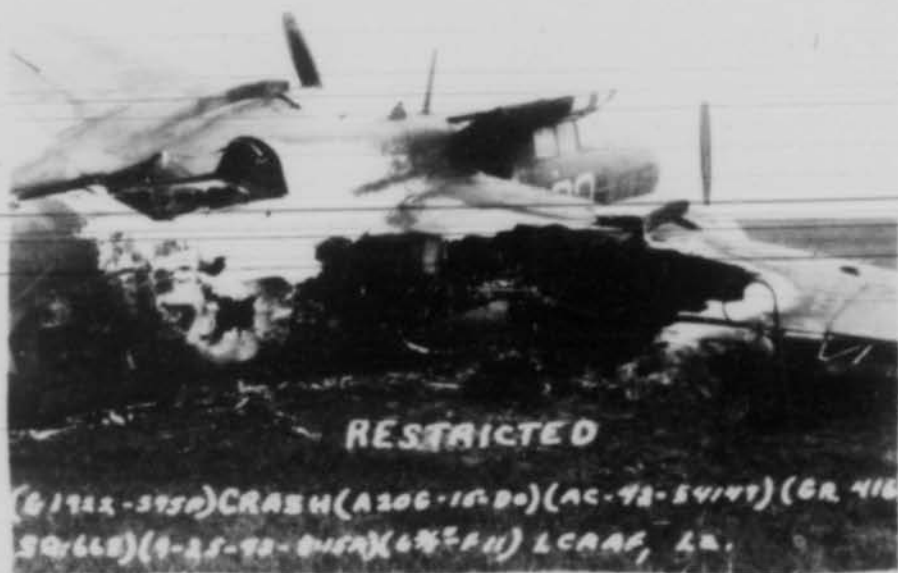
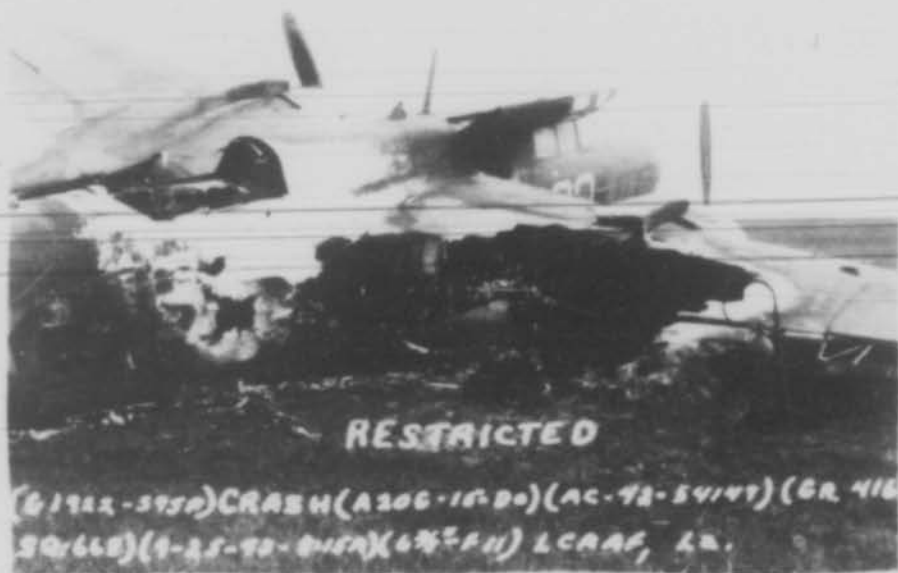
CRASH (A306-15-00) (AC-78-54147) (GR 416
80-668) (9-25-78-0157) (67-7-11) LCAAF, LA.

DAMAGE	(46) LIST OF DAMAGED PARTS
(46) Aircraft..... <u>W 5</u>	<u>Right wing, fuselage, right nacelle and landing gear burned beyond repair.</u>
(47) Engine(s)..... <u>None 1</u>	
(48) Propeller(s)..... <u>None 1</u>

The main gasoline lines were burned in two, which made the fire difficult to extinguish.

Following the fire, it was impossible to get any idea as to how the fire originated, due to the burned condition of the nacelles, landing gear, wing, etc., but the past experience of Mr. Norman H. Milstead, Douglas Aircraft representative, sheds light on a very possible cause of the fire, as he has seen similar occurrences, and in a couple of cases, the fire was extinguished before too much damage was done, and the following explanation for these fires, which could apply to this fire is offered: The fuel pressure gauge line, carburetor to hose fitting on the fire wall, became disconnected, allowing gasoline to run down the front of the fire wall and into the nacelles through the nacelle doors, and the gasoline was ignited by the exhaust. Following this, the main gasoline lines from the two right tanks were burned through, causing the greatest part of the fire.

1. That fuel pressure gauge lines on all B-7 and A-20 type airplanes be replaced with flexible lines as installed in A-20C-20D0 type airplanes.
2. That above connections be observed closely on each preflight inspection for an indefinite period of time.
3. That fire extinguisher equipment for both the engine and accessory section be kept in training type airplanes.
