45-8-11-520-1

REPORT OF AIRCRAFT ACCIDENT

AIRCRAFT: (4) Type and model A-20G-25 (5) A. F. No. 43-9568 (6) Station AAF Station 170

(57) Cause of accident Left main landing gear collapsed on landing.

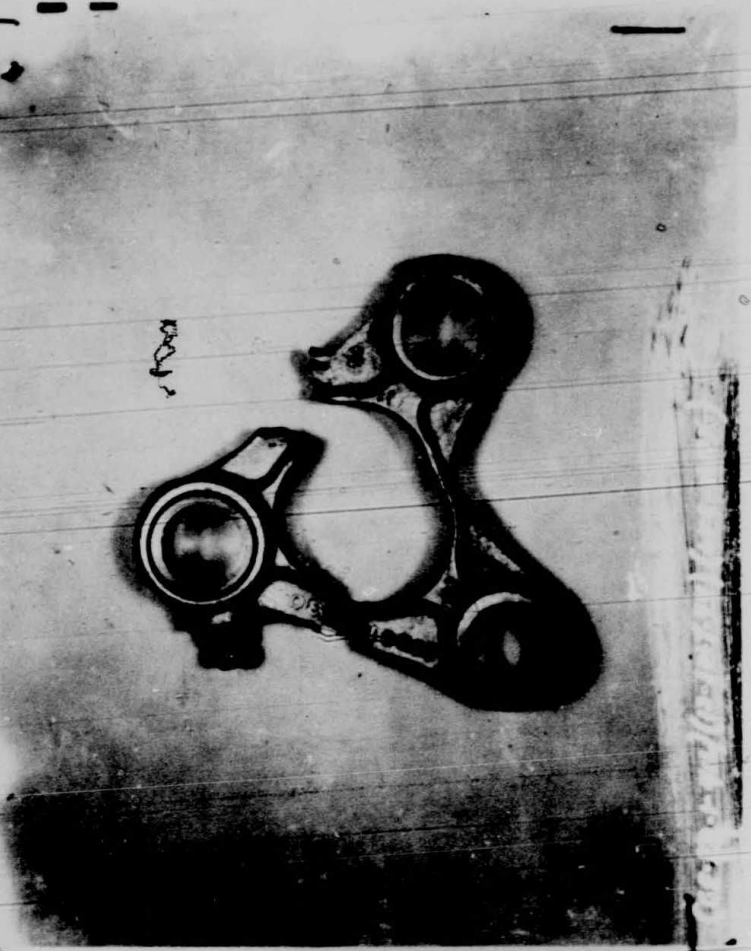
(GAO-19-2-414) (11-AUG-49) (CRASH-LANDING)

Investigation disclosed that the Lug Assembly of the Landing Gear Actuating Cylinder anchor had broken, causing the gear to collapse. The cause was materiel failure. (60)

Upon examination of A-20G-25 aircraft, AAF serial No 43-9368, following its landing accident on AAF Station 170 at 1340, 11 August 1944, it was discovered that the left main landing gear had collapsed due to a materiel failure of the landing gear actuating cylinder anchor lug assembly, Part No 1066938.

The left main landing gear collapsed on landing. After the Airplane was lifted, the gear snapped down into place and locked. Investigation disclosed that the Lug Assembly, Landing Gear Actuating Cylinder Anchor, Part Number 1066938, had broken, causing the gear to collapse.
